POSTER ABSTRACT

## Cyclododecane as temporary protection on distemper wall paintings prior to plaster consolidation: the temple restoration project in Sikkim

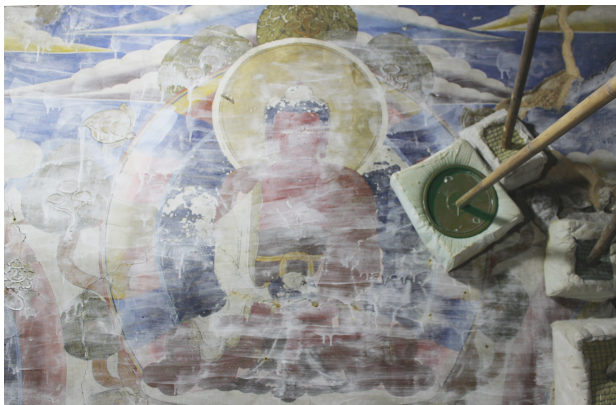
**Figure 1** Detail of the Guru Lakhang paintings in Singhik monastery (North Sikkim, India) during plaster consolidation. CDD has been applied in solution to protect the paintings during grout injection, then padded tools are applied after the injection. Image: Mélodie Bonnat.

However, temporary protection is absolutely necessary in order to proceed safely to plaster consolidation. Due to strong vibrations from earthquakes, plasters are commonly detached from the wall so consolidation is necessary. Grout injection is a delicate consolidation method: grouts are finely sieved liquid mortars based on soil or lime, that are injected with manual syringes between plaster and wall. It is crucial to avoid grout leaks at the surface of the original paintings, since stains from grout on matte paint are almost impossible to clean. In order to protect the paintings, cyclododecane (from CTS Delhi) was tested. It was prepared in saturated solution with cyclohexane (from Central Drug House, Delhi), slightly heated in a convenient electrical baby milk bottle heater and applied with a smooth brush on the paintings (**Figure 1**). During this operation, the conservator wears appropriate mask and gloves. The cyclododecane layer was very thin and almost transparent but thick enough to repel grout leaks (PLM-A from CTS) and protect the paint layer during the grout injection. After three days, the cyclododecane was totally sublimed, having protected the decorated surface from all residues and successfully preserved the matte and bright appearance of the paint layer (**Figure 2**).

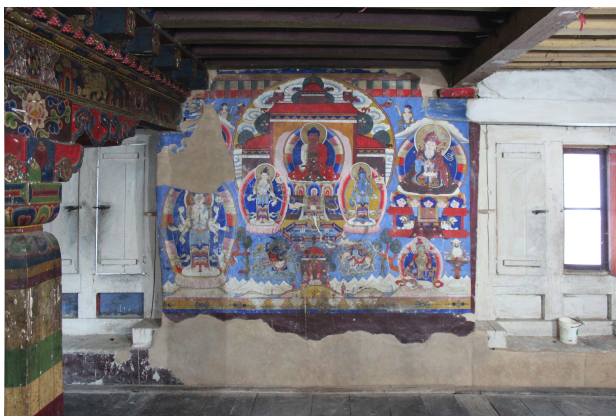
**Figure 2** View of the Kangyur Lakhang paintings in Singhik monastery after plaster consolidation. The CDD has totally sublimed after one month. Image: Mélodie Bonnat.
